Coal Combustion Waste Impoundment

Round 5 - Dam Assessment Report

Winyah Generating Station (Site #004)

Santee Cooper

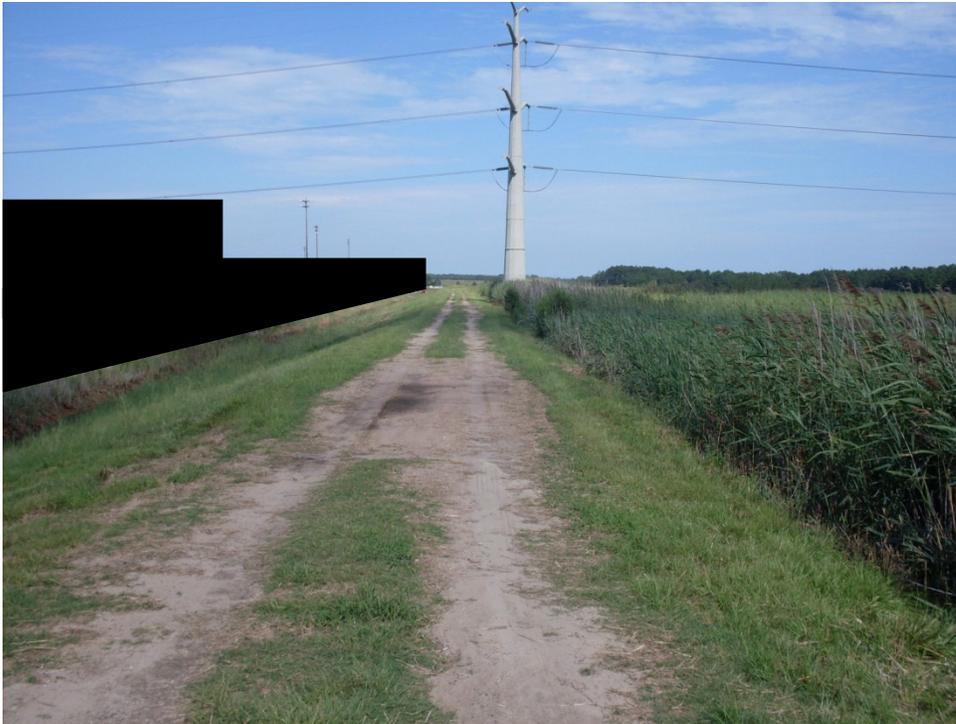
Photo BS-4: Crest of Perimeter Dike North Side of South Ash Pond – Viewed East.

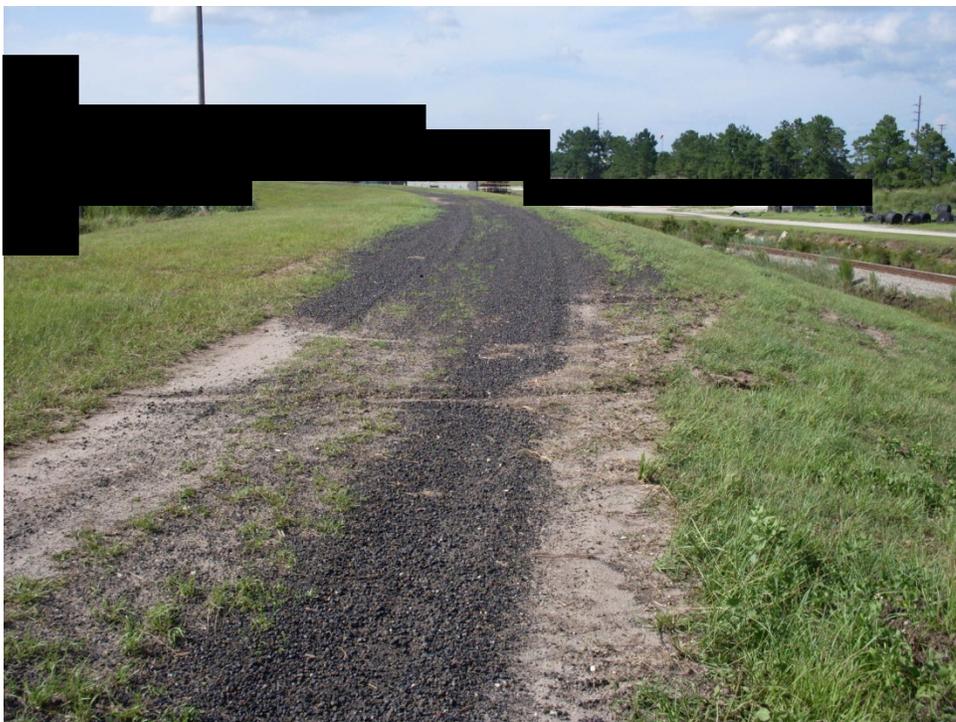
Photo BS-5: Crest of Perimeter Dike on East Side of South Ash Pond Near Decant Tower – Viewed North.

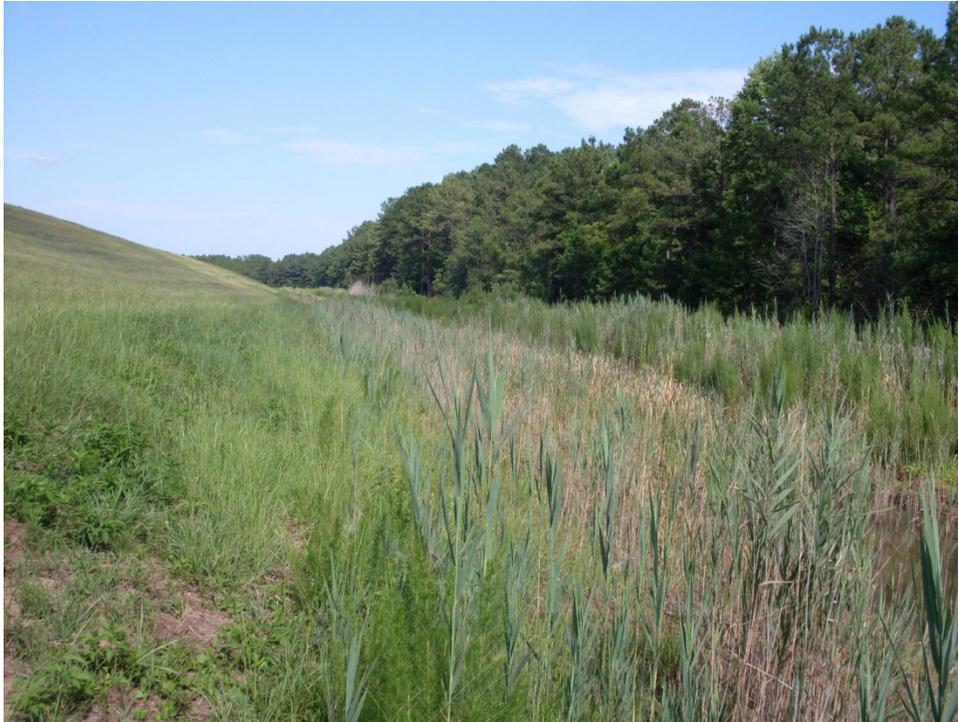
Photo BS-6: Outside Slope and Toe of Perimeter Dike at Southwest Bend of South Ash – Viewed East.

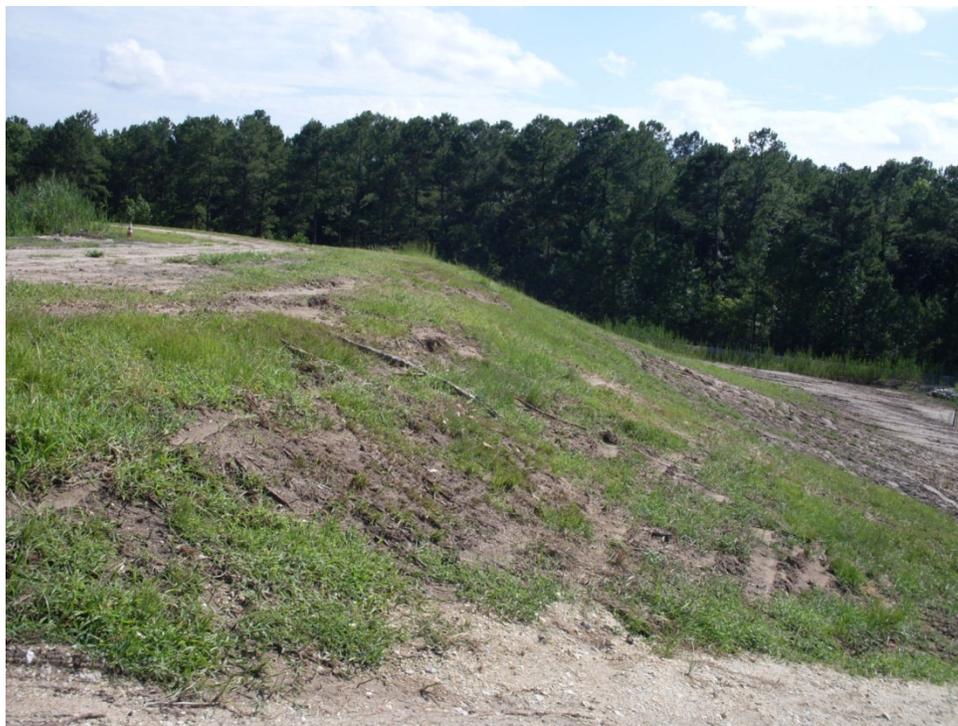
Photo BS-7: Crest and Outside Slope of Perimeter Dike on West Side of South Ash Pond.

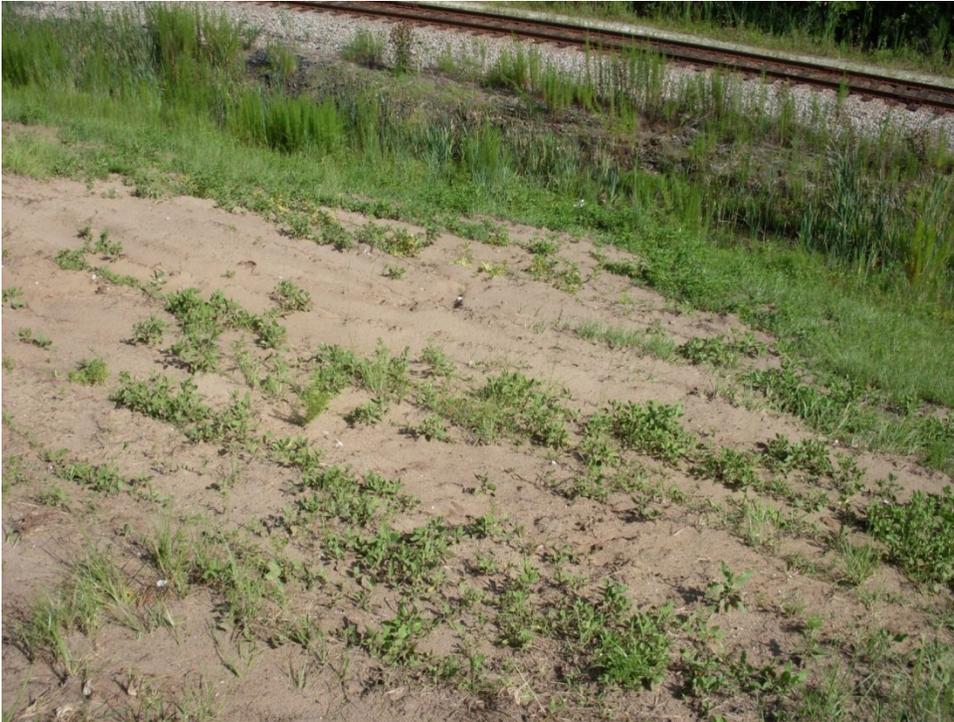
Photo BS-8: Area of Sparse Vegetation Outside Toe of Perimeter Dike South Side of Ash Pond Near Southeast Corner.

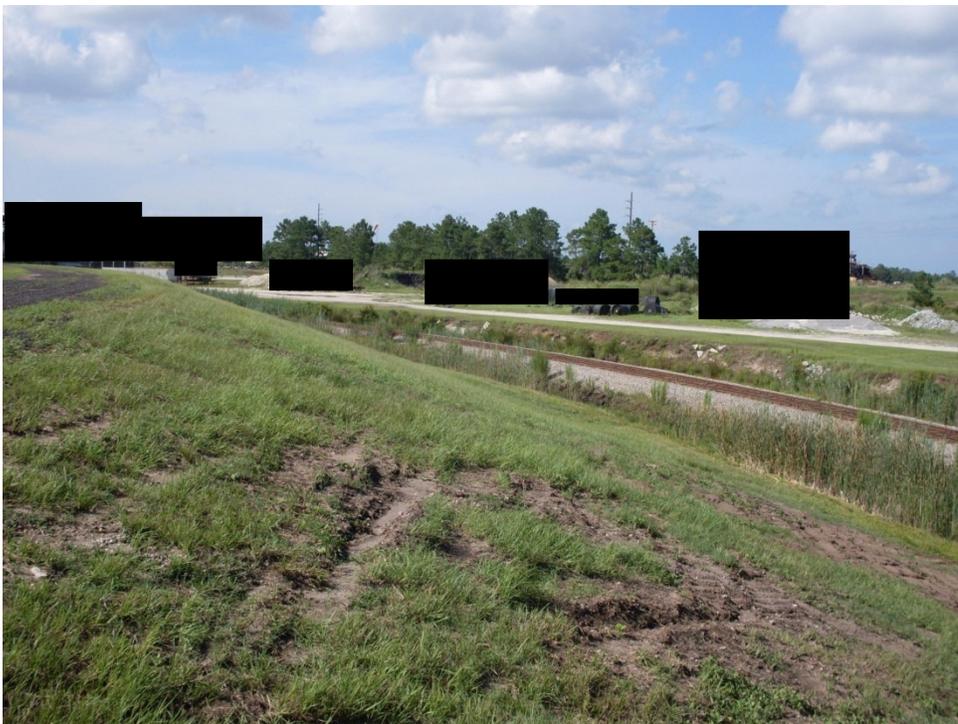
Photo BS-9: Outside Slope of Perimeter Dike East Side of South Ash Pond Near Decant Tower – Viewed North.

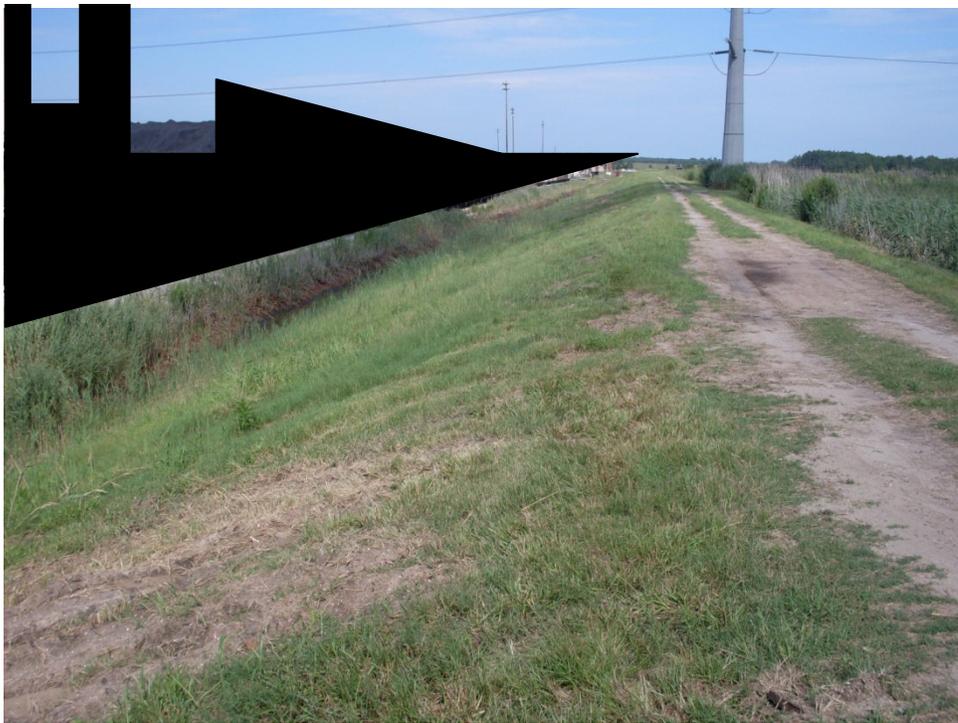
Photo BS-10: Outside Slope of Perimeter Dike North Side of South Ash Pond – Viewed East.

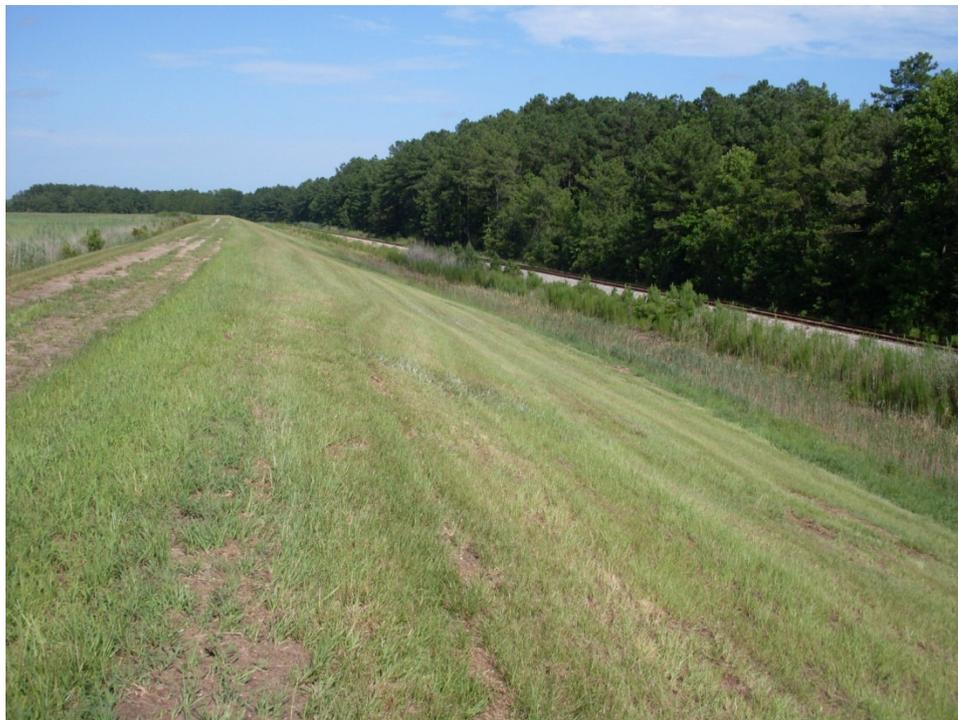
Photo BS-11: Outside Slope of Perimeter Dike South Side of South Ash Pond – Viewed East.

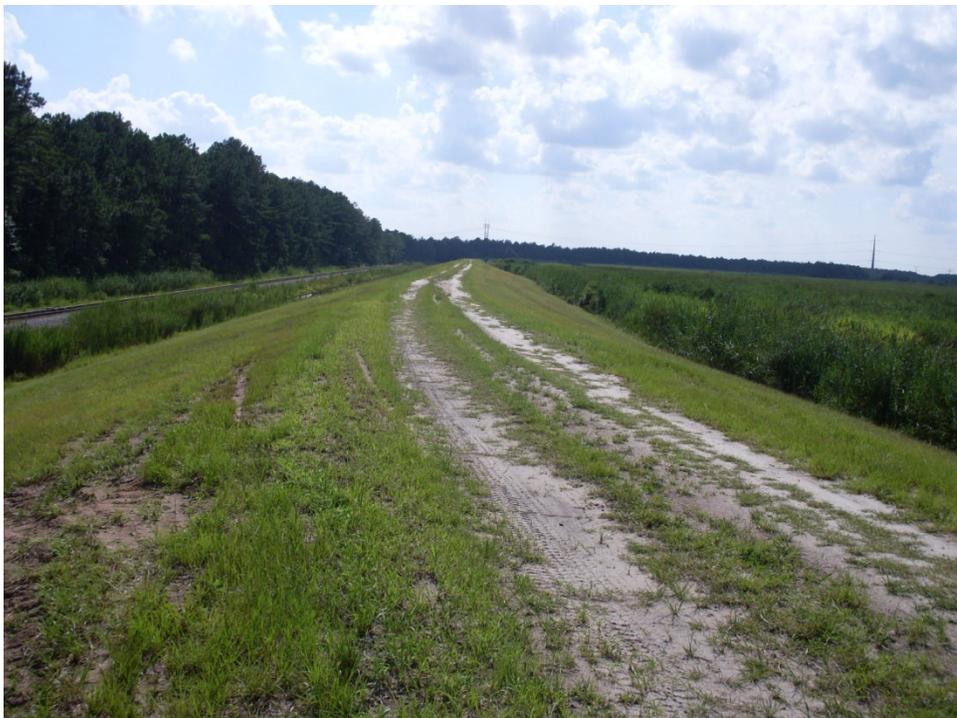
Photo BS-12: Outside Slope and Crest of Perimeter Dike on South Side of South Ash Pond – Viewed West from Southeast Corner.

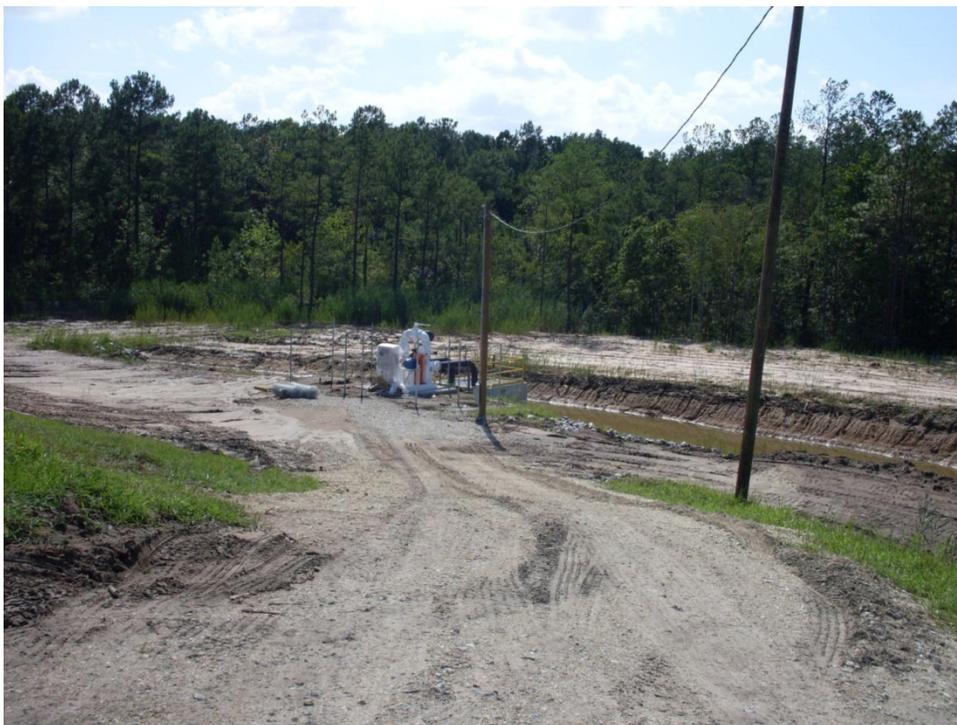
Photo BS-13: New Pump Station at Outside Perimeter Toe Ditch Northeast Side of South Ash Pond (For Pumping \Water from Toe Ditch Through Buried Line Into South Ash Pond).

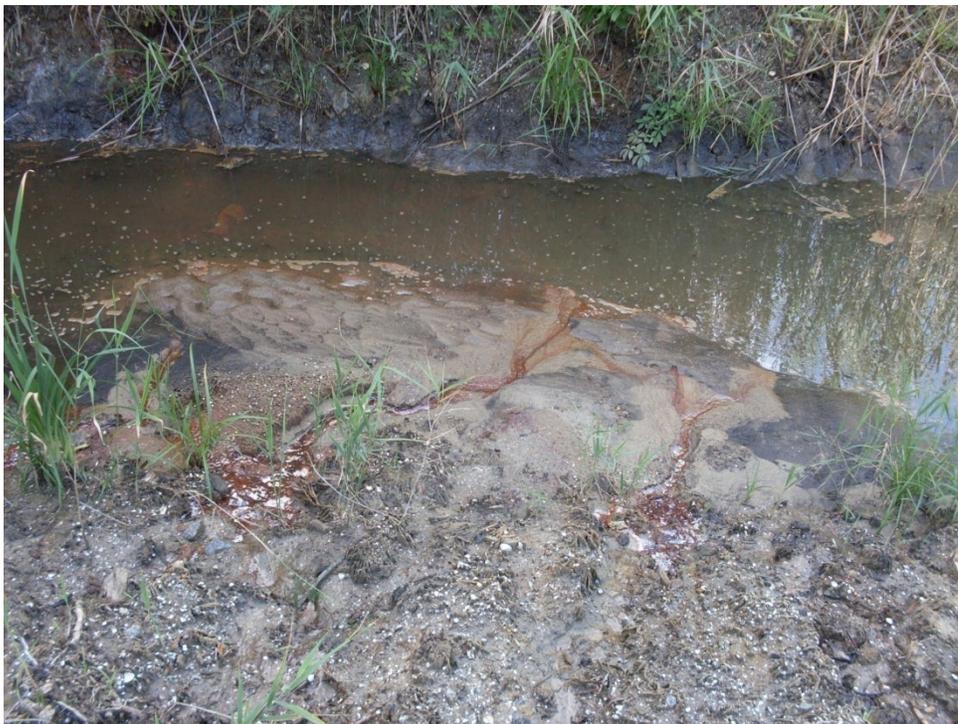
Photo BS-15: Small Seeps at Outside Toe Ditch North Side of South Ash Pond.

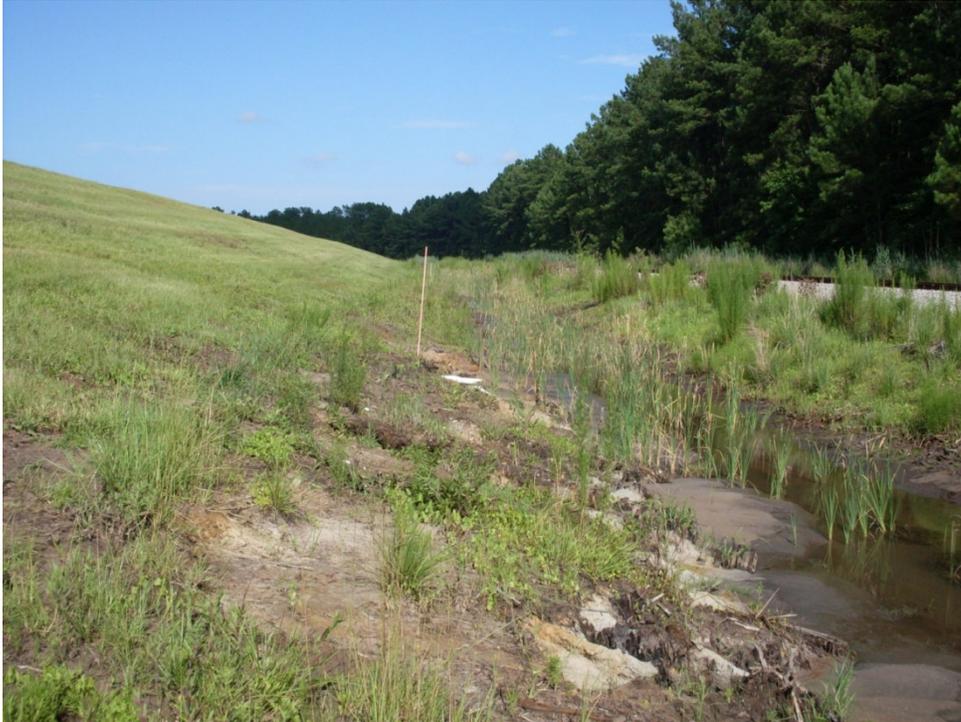
Photo BS-16: Outside Slope of Perimeter Dike and Toe Ditch South Side of South Ash Pond B – Viewed East.

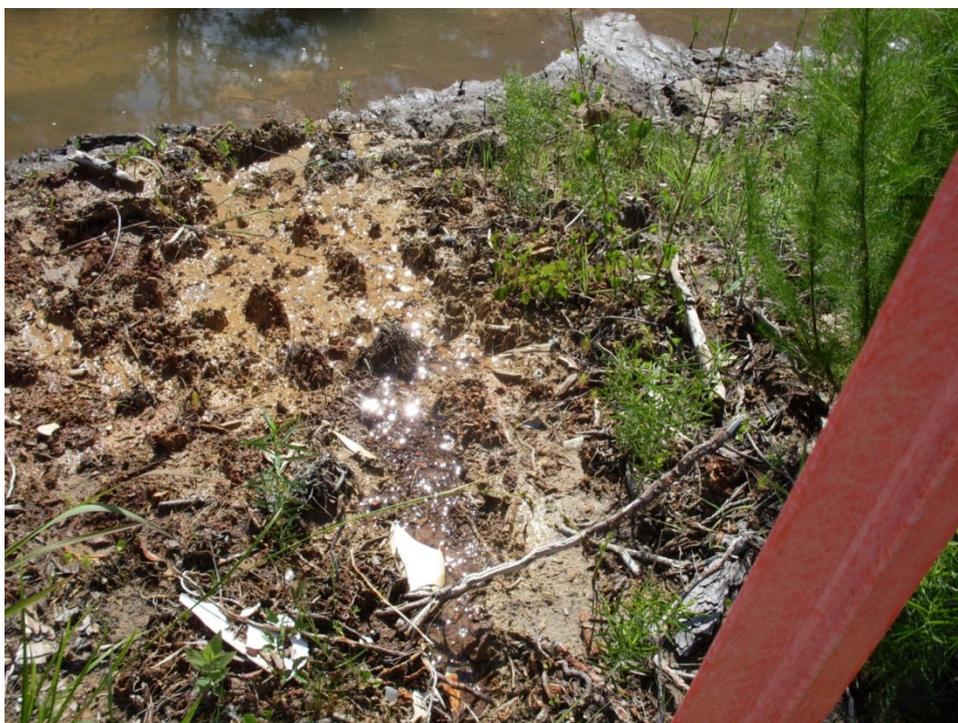
Photo BS-19: Wet Ground and Seepage from Toe Drain PVC Pipe Outlet at Outside Toe of South Ash Pond Perimeter Dike at Southwest Bend End.

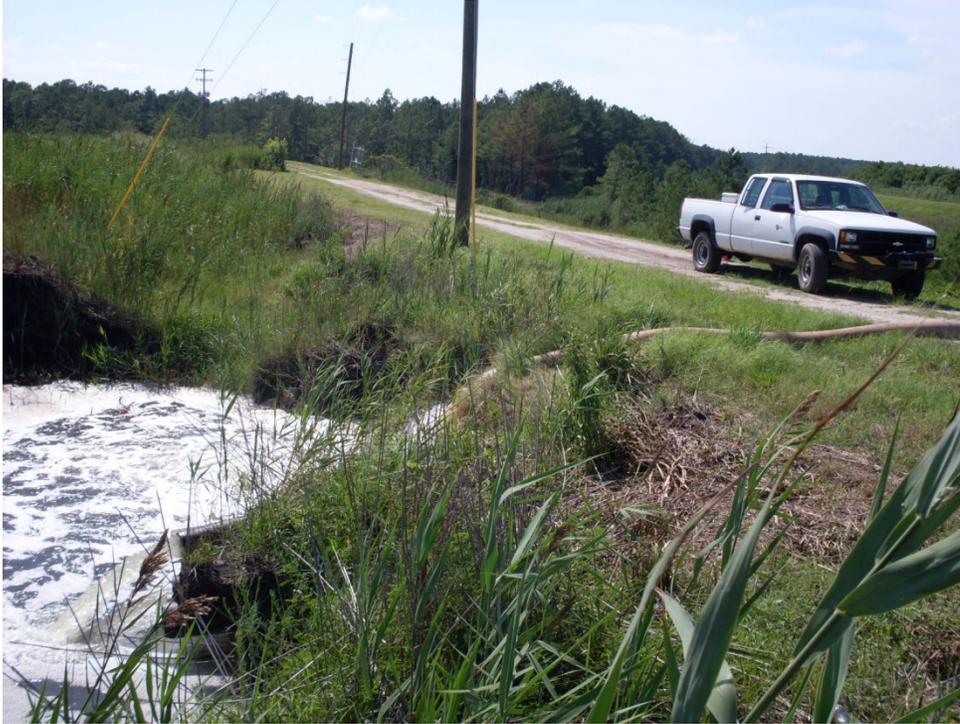
Photo BS-20: Photo BS-16: Inside South Ash Pond Where Water Pumped From West Ash Pond is Discharged Through Flexible Liner Over The North Perimeter Dike Near West End.

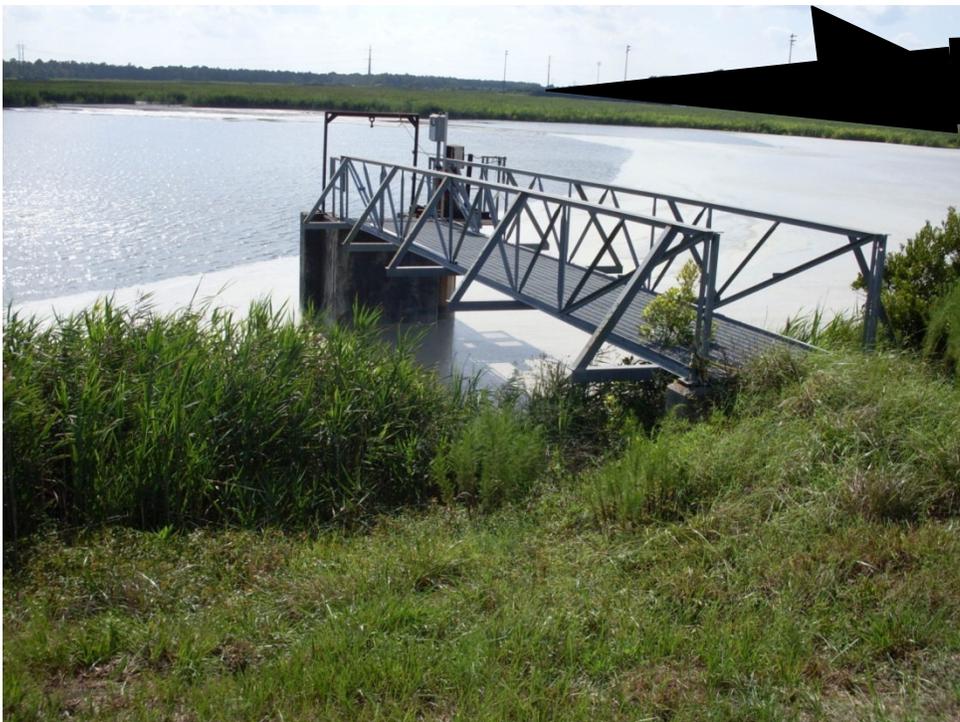
Photo BS-21: Decant Tower at East End of South Ash Pond.

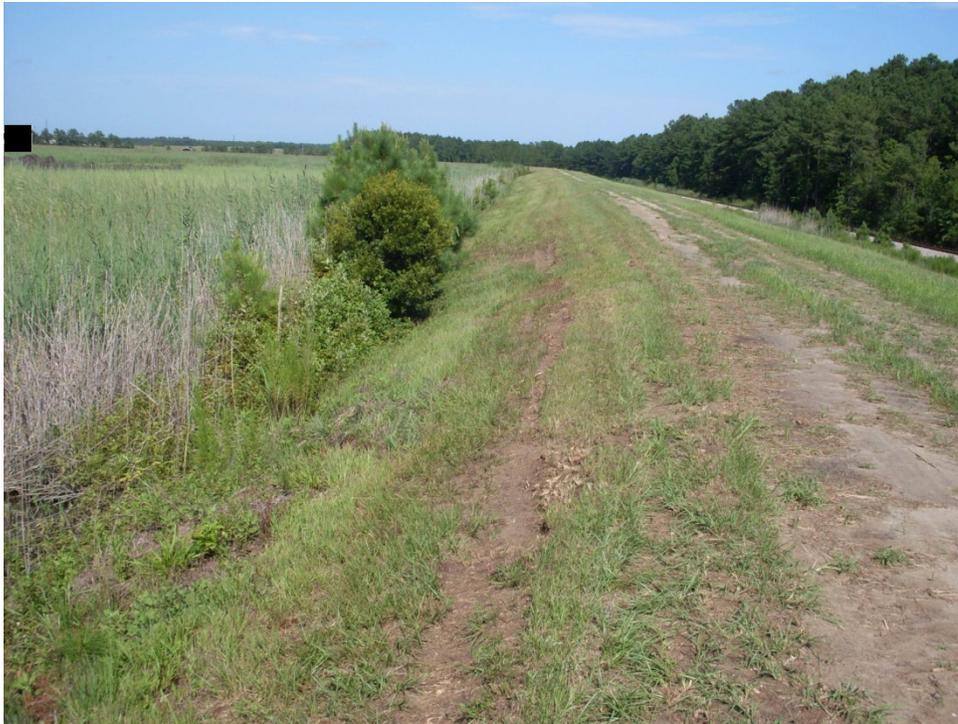
Photo BS-22: Inside Slope and Crest Perimeter Dike South Side of South Ash Pond– Viewed East.

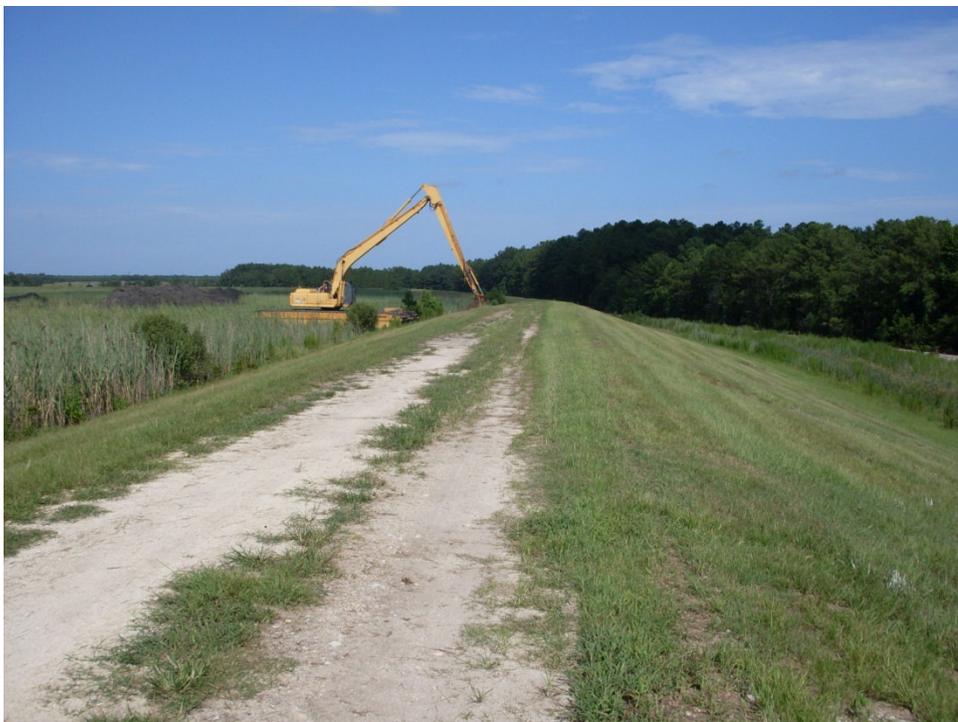
Photo BS-23: Inside Slope and Crest of Perimeter Dike of South Ash Pond at Southwest Bend – Viewed East.

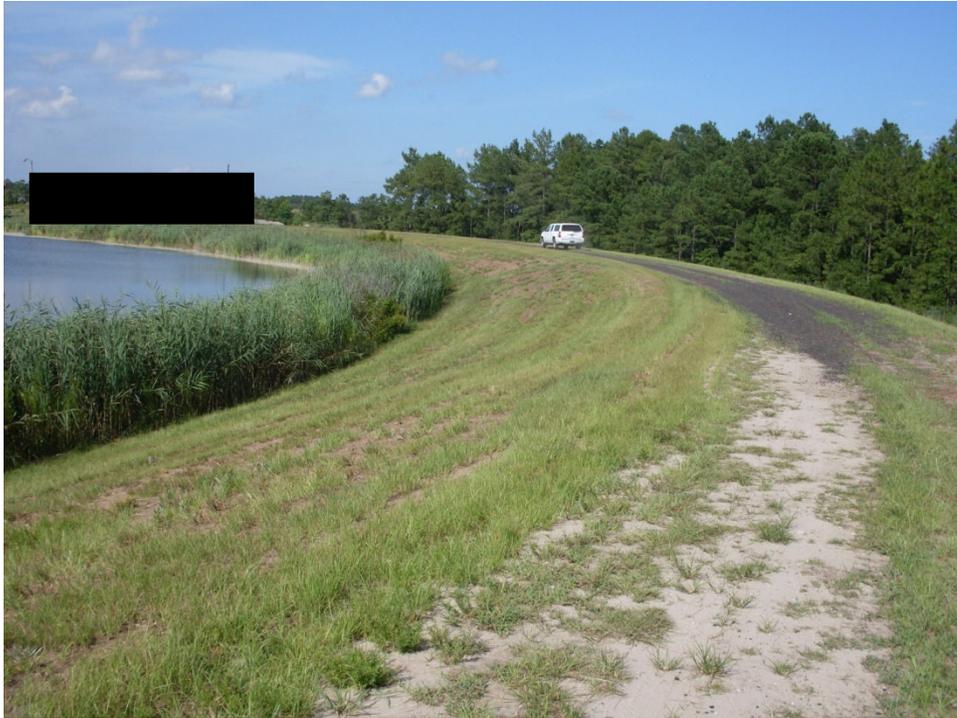
Photo BS-24: Inside Slope of Perimeter Dike Southeast Corner of South Ash Pond– Viewed Northeast.

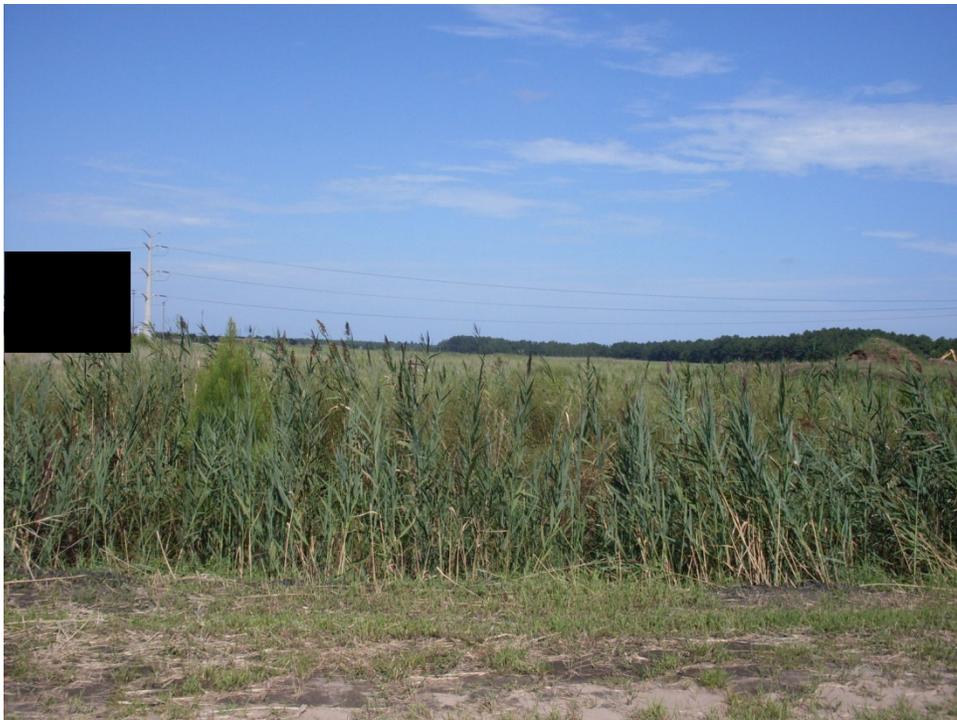
Photo BS-25: Tall Vegetation on Ash Surface and Inside Slope of Perimeter Dike of South Ash Pond at Western End – Viewed East.

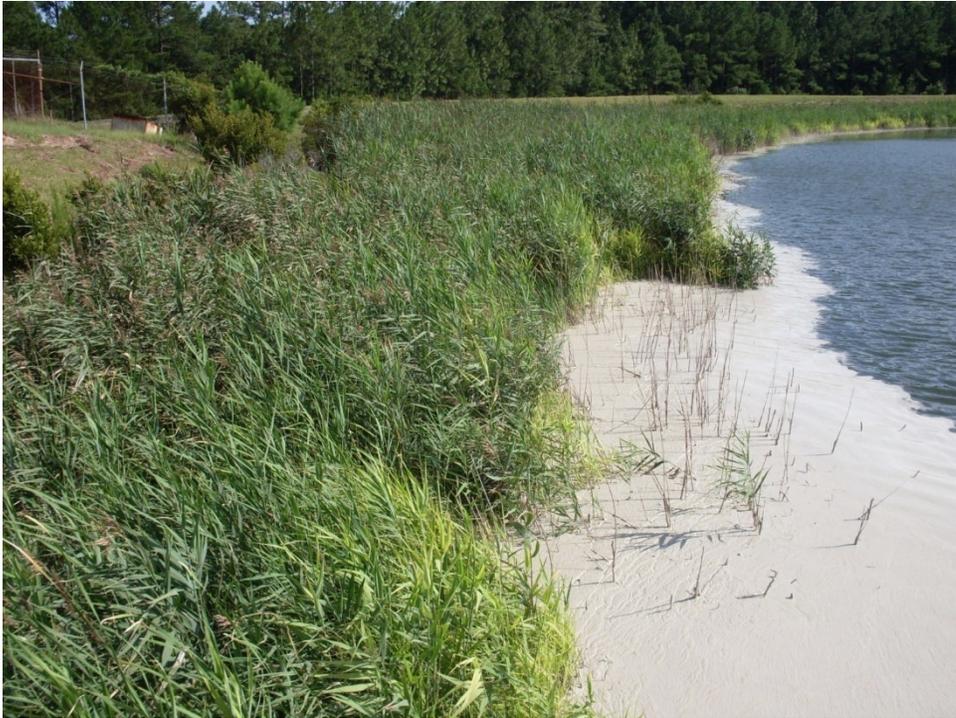
Photo BS-26: Inside Slope of Perimeter Dike East Side of South Ash Pond Near Decant Tower – Viewed South.

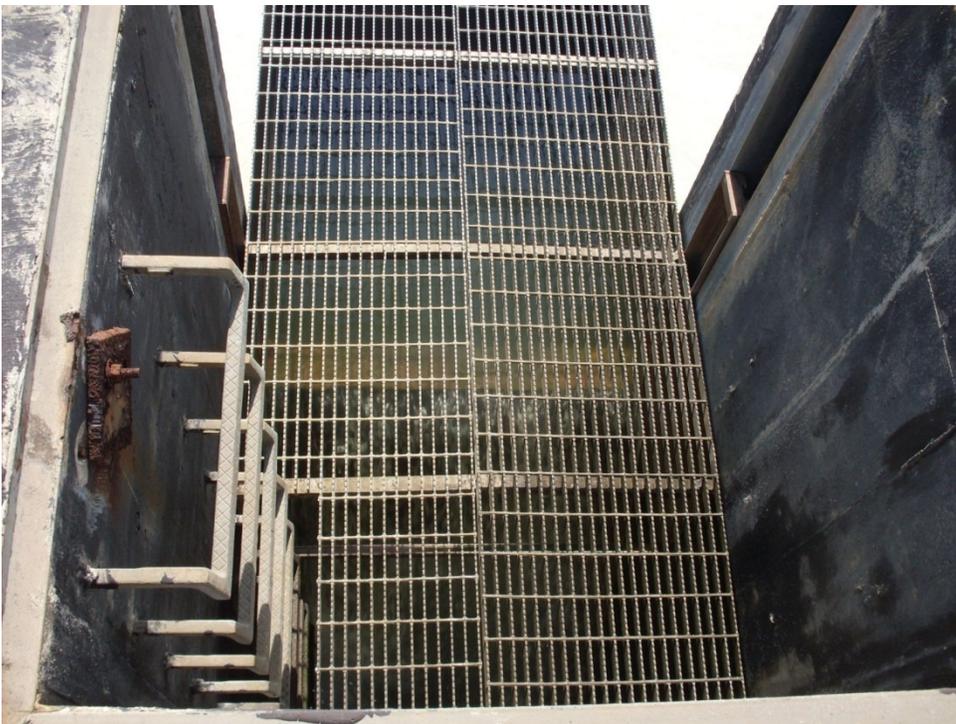
Photo BS-27: View Through Top Grate of South Ash Pond Decant Tower.

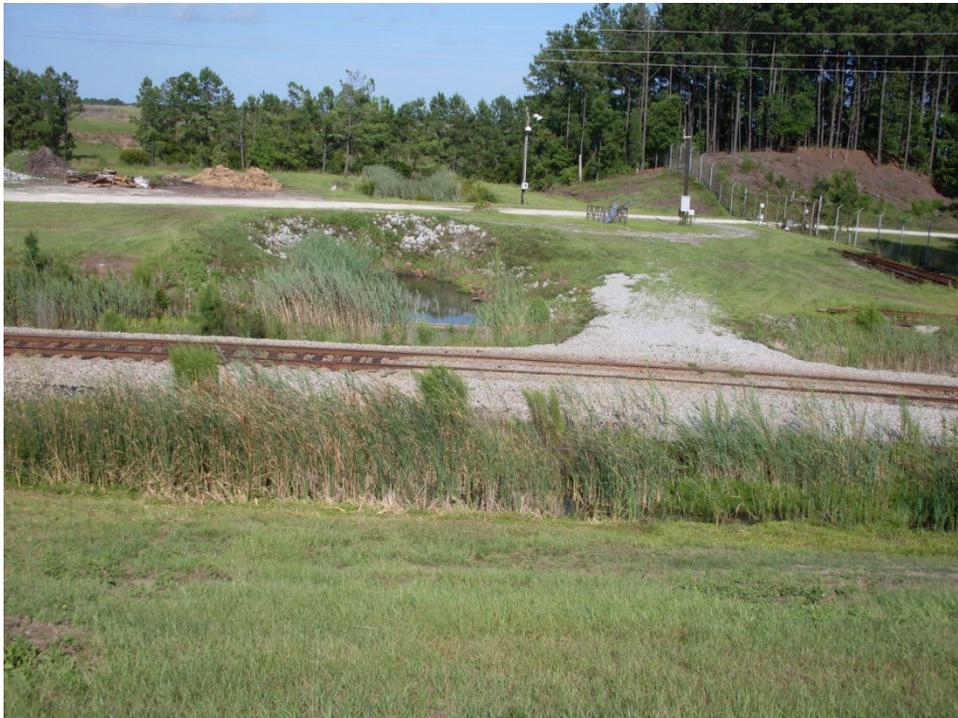
Photo BS-28: Outside Toe of Perimeter Dike East Side of South Ash Pond

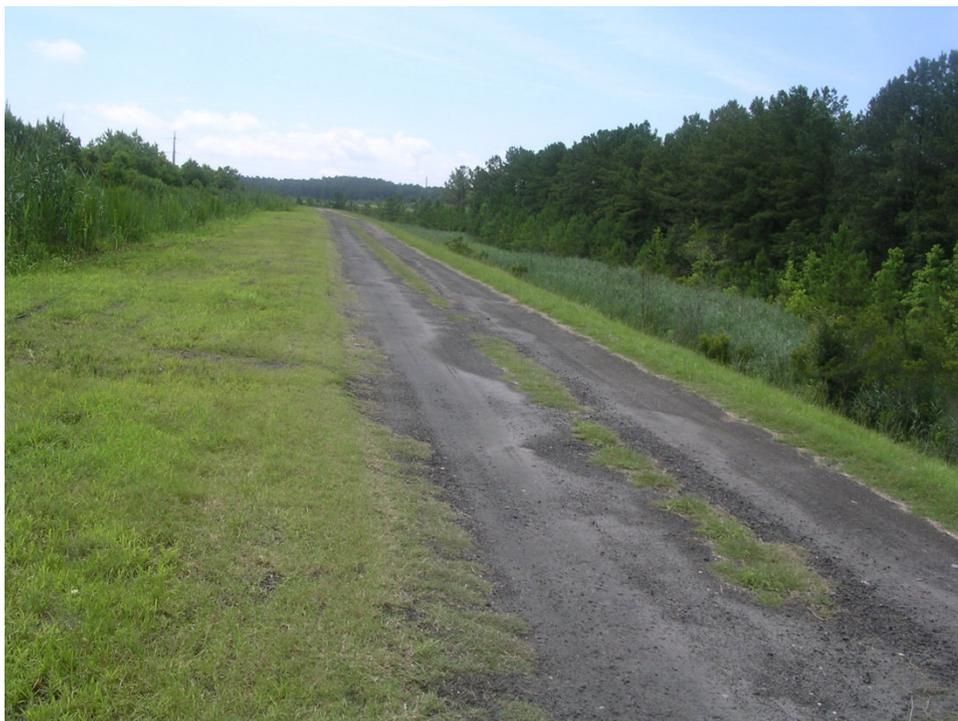
Photo BW-1: Crest along Southwest Perimeter Dike of West Ash Pond – Viewed Southeast.

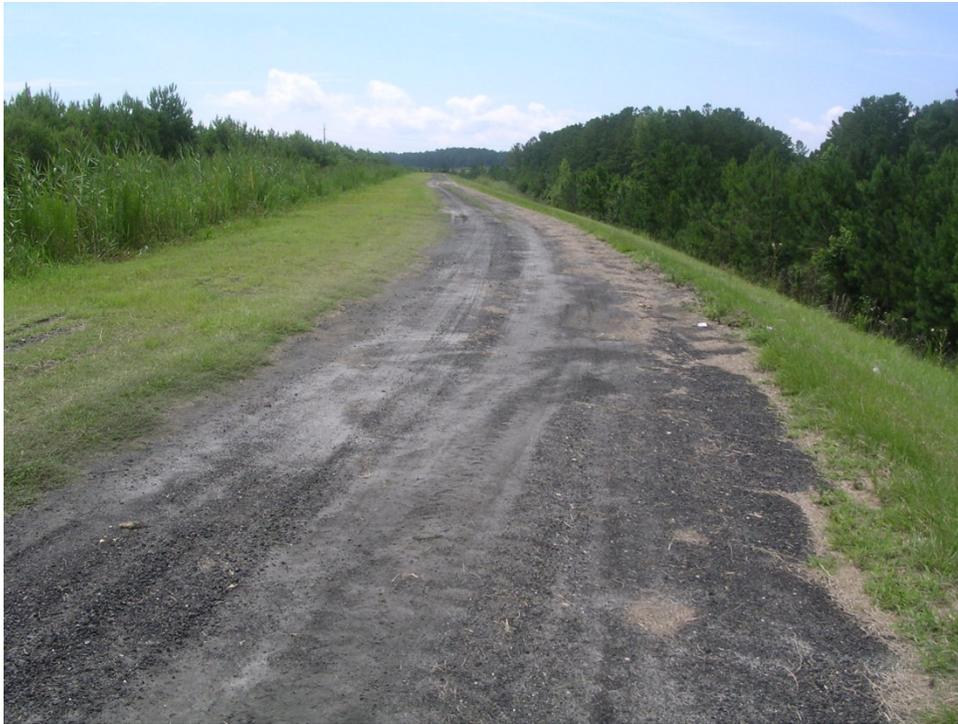
Photo BW-2: Crest of Perimeter Dike Southwest Side of West Ash Pond – Viewed Southeast.

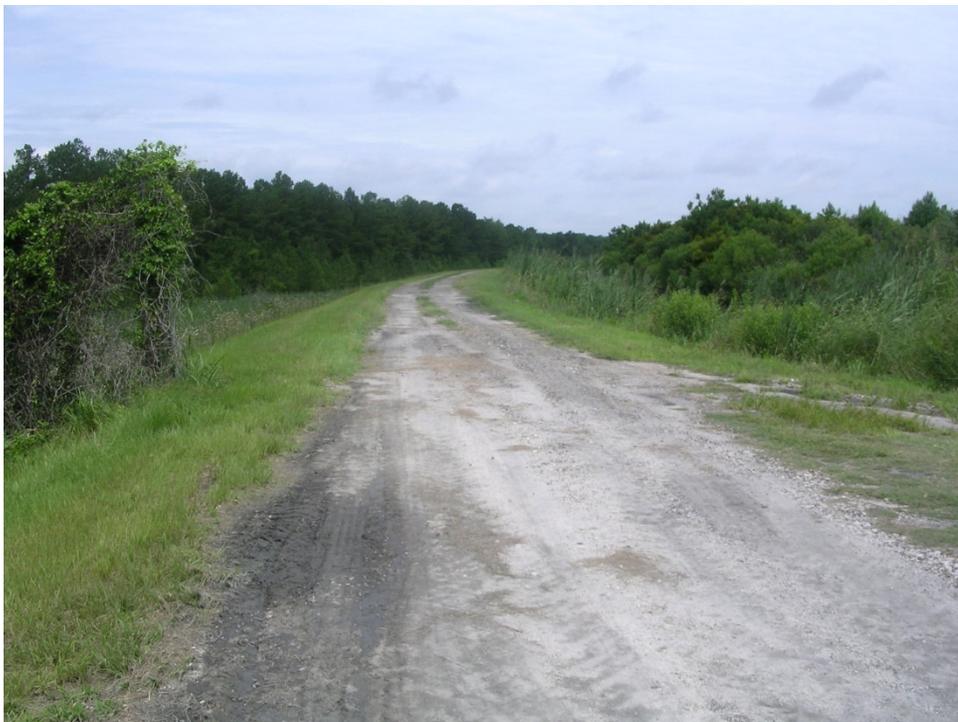
Photo BW-3: Crest of Perimeter Dike Along Southwest Corner of West Ash Pond – Viewed Northwest.

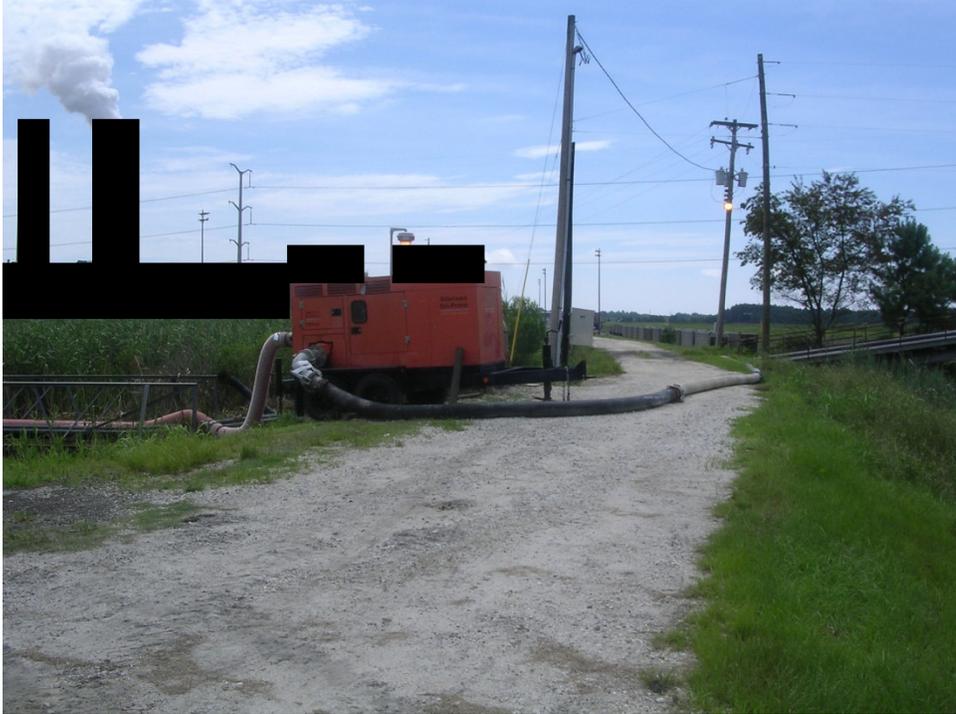
Photo BW-4: Intake Line and Discharge Lines for Pumping Water from West Ash Pond to South Ash Pond. View of Pump Located on Crest Along Southeast Corner of West Ash Pond – Viewed East.

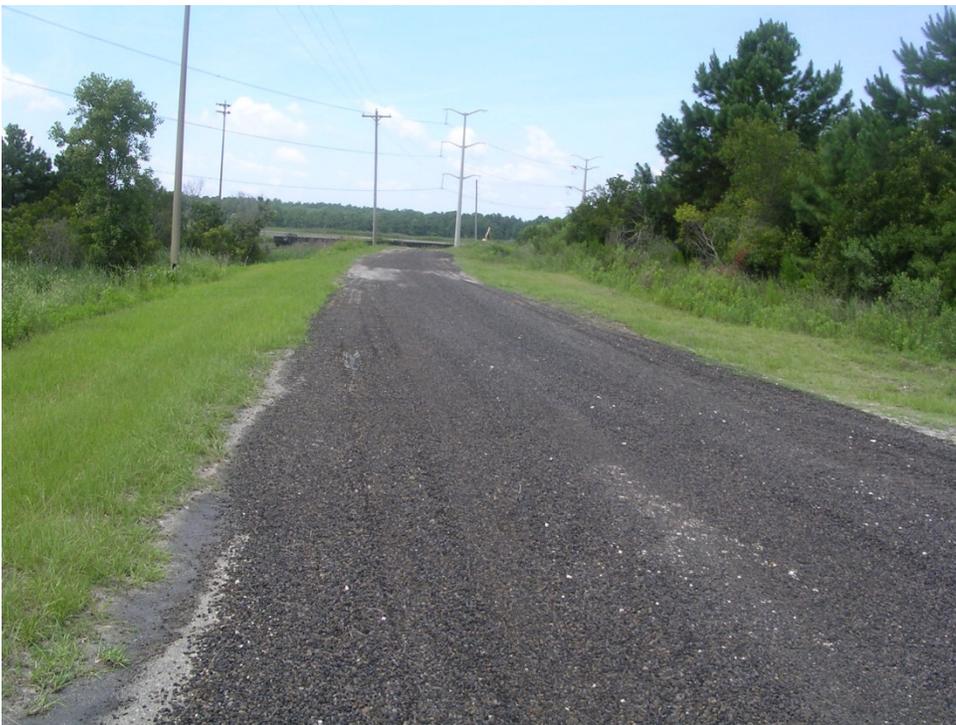
Photo BW-5: Crest of Perimeter Dike East Side of West Ash Pond– Viewed South.

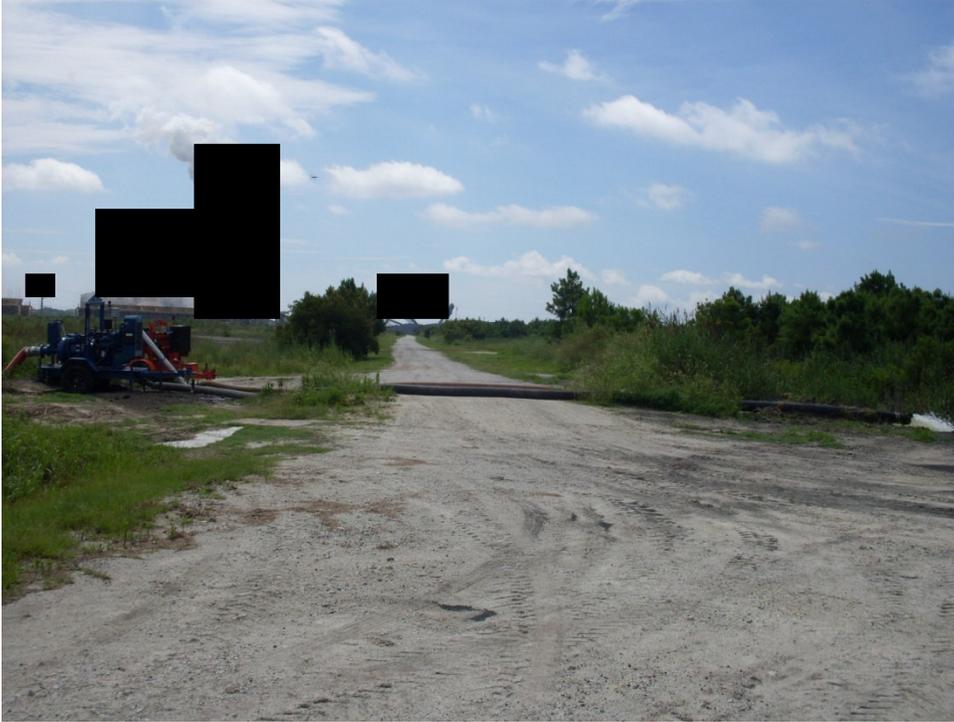
Photo BW-6: Cross Dike between Unit 3 & 4 Slurry Pond and West Ash Pond– Viewed Southeast.

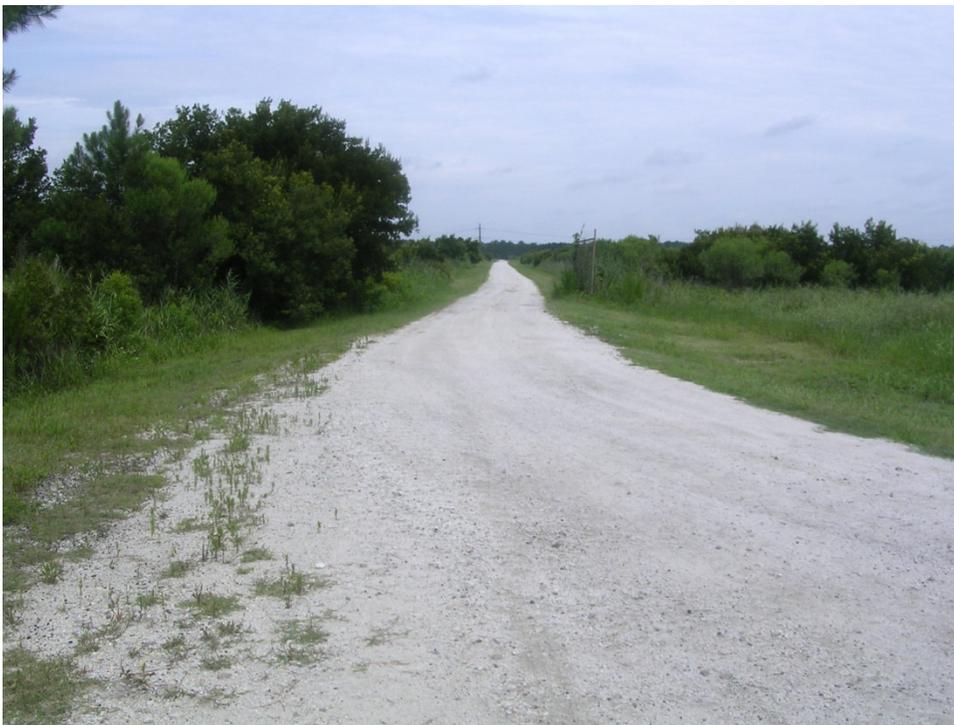
Photo BW-7: Cross Dike between West Ash Pond and Unit 3 & 4 Slurry Pond – Viewed Northwest.

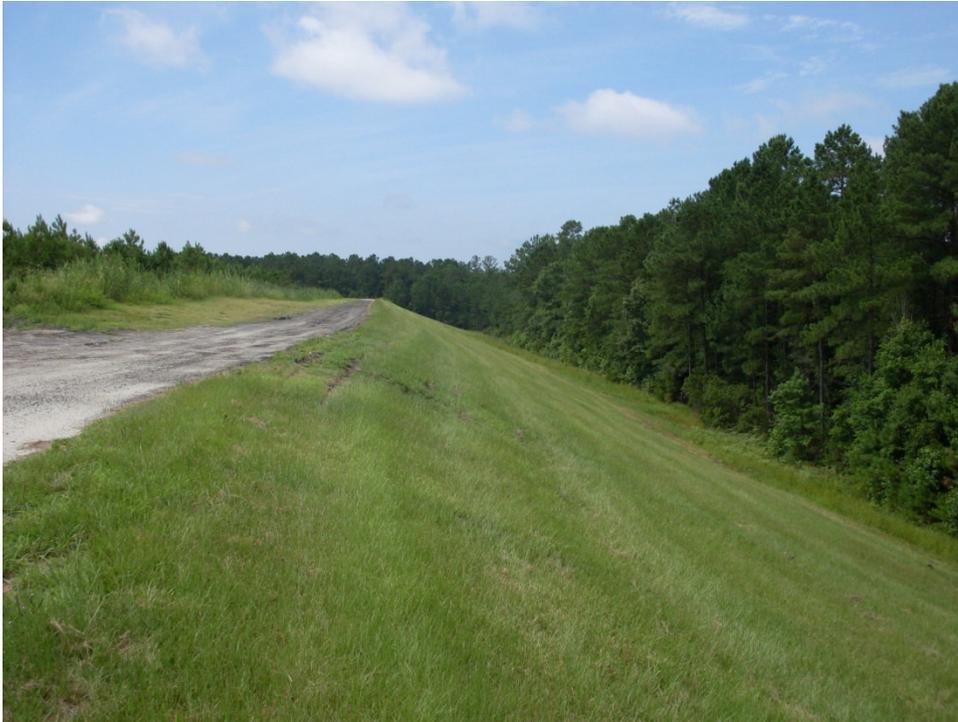
Photo BW-8: Crest and Outside Slope of Perimeter Dike to Along West Side of West Ash Pond– Viewed South.

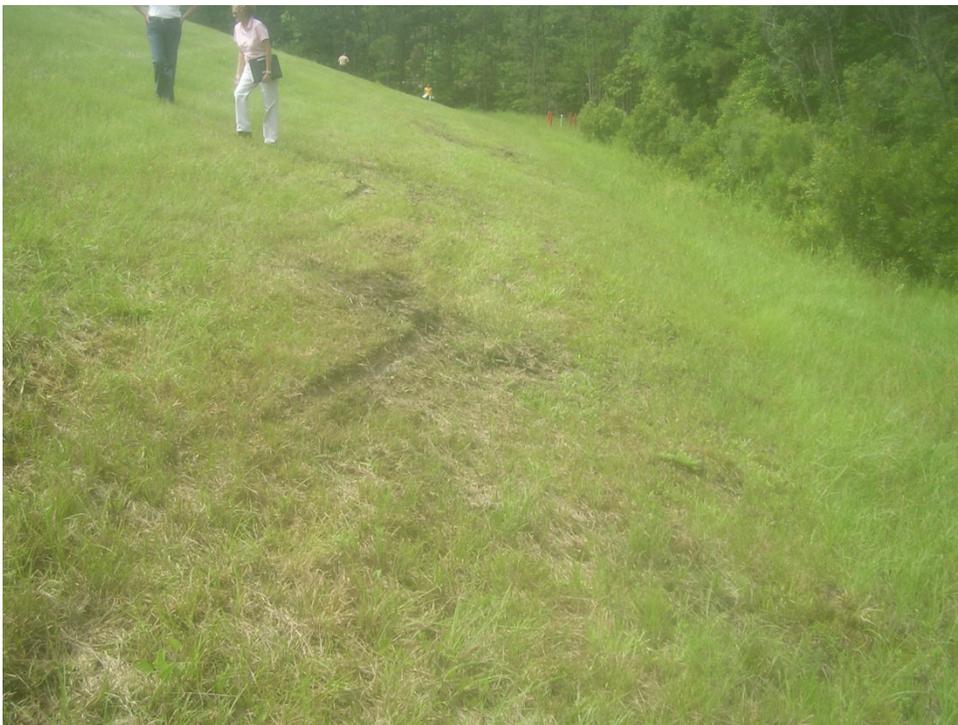
Photo BW-9: Outside Toe of Perimeter Dike West Side of West Ash Pond – Viewed South (Note Mower Ruts Due to Wet Soil).

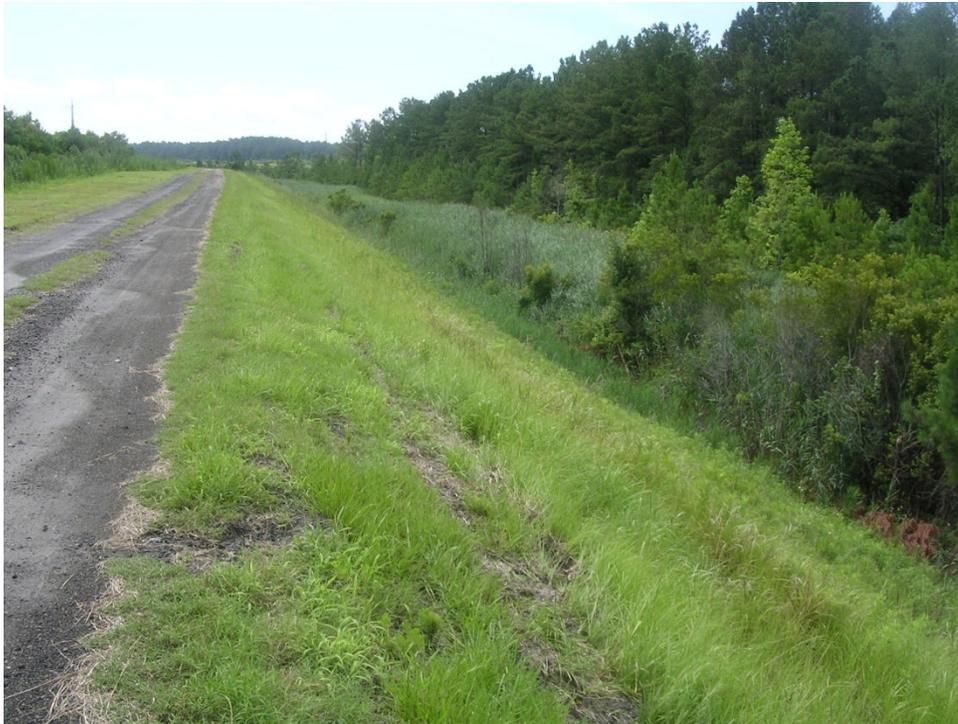
Photo BW-10: Outside Slope Perimeter Dike Southwest Side of West Ash Pond – Viewed Southeast.
